## Memorandum

*Subject: Summary of Oversight of Physical Water Column Monitoring and Equipment Servicing  
July 29–August 1, 2019  
Lower Passaic River Restoration Project*

On behalf of the United States Environmental Protection Agency (EPA) and the United States Army Corps of Engineers (USACE), Kansas City District, CDM Federal Programs Corporation (CDM Smith) traveled to the Lower Passaic River Study Area (LPRSA) on Monday, July 29 through Thursday, August 1, 2019 and provided field technical oversight for the first round of surface water sampling and second round of mooring servicing associated with the Physical Water Column Monitoring (PWCM) program.

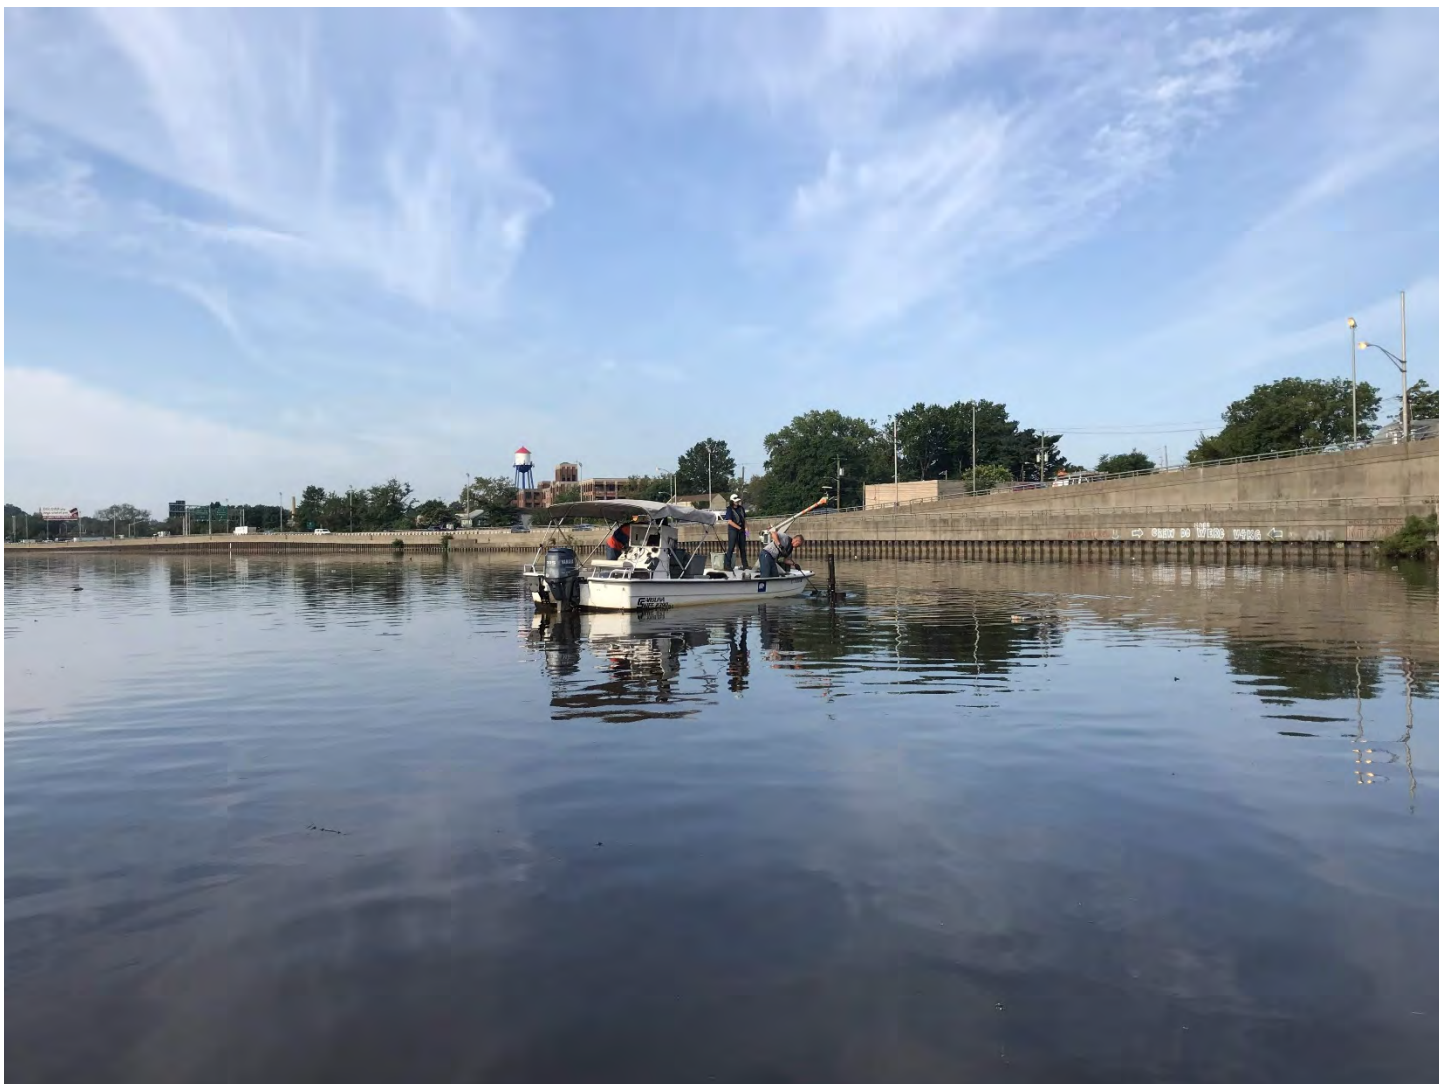
Photograph 14: Retrieving and cleaning RM 8.4 mooring.

The RM 8.4 bottom mooring locator buoy was released, and the mooring was retrieved. The bottom-mounted YSI was removed and cleaned, and had its data downloaded, had its wiper confirmed functional, and was compared against the calibrated boat YSI. The comparison was good. The turbidity sensor had accumulated some grime under the wiper, so the wiper head was replaced. The ADCP was removed, cleaned, had its data downloaded, and its four sensors were confirmed to be functional. The ADCP battery was replaced and its compass was recalibrated. Both the ADCP and YSI were remounted, and the locator buoy was reset. The mooring was then lowered back to its original position using the GPS located above the winch arm. A second vertical YSI profile was collected at RM 8.4 to bracket the data.

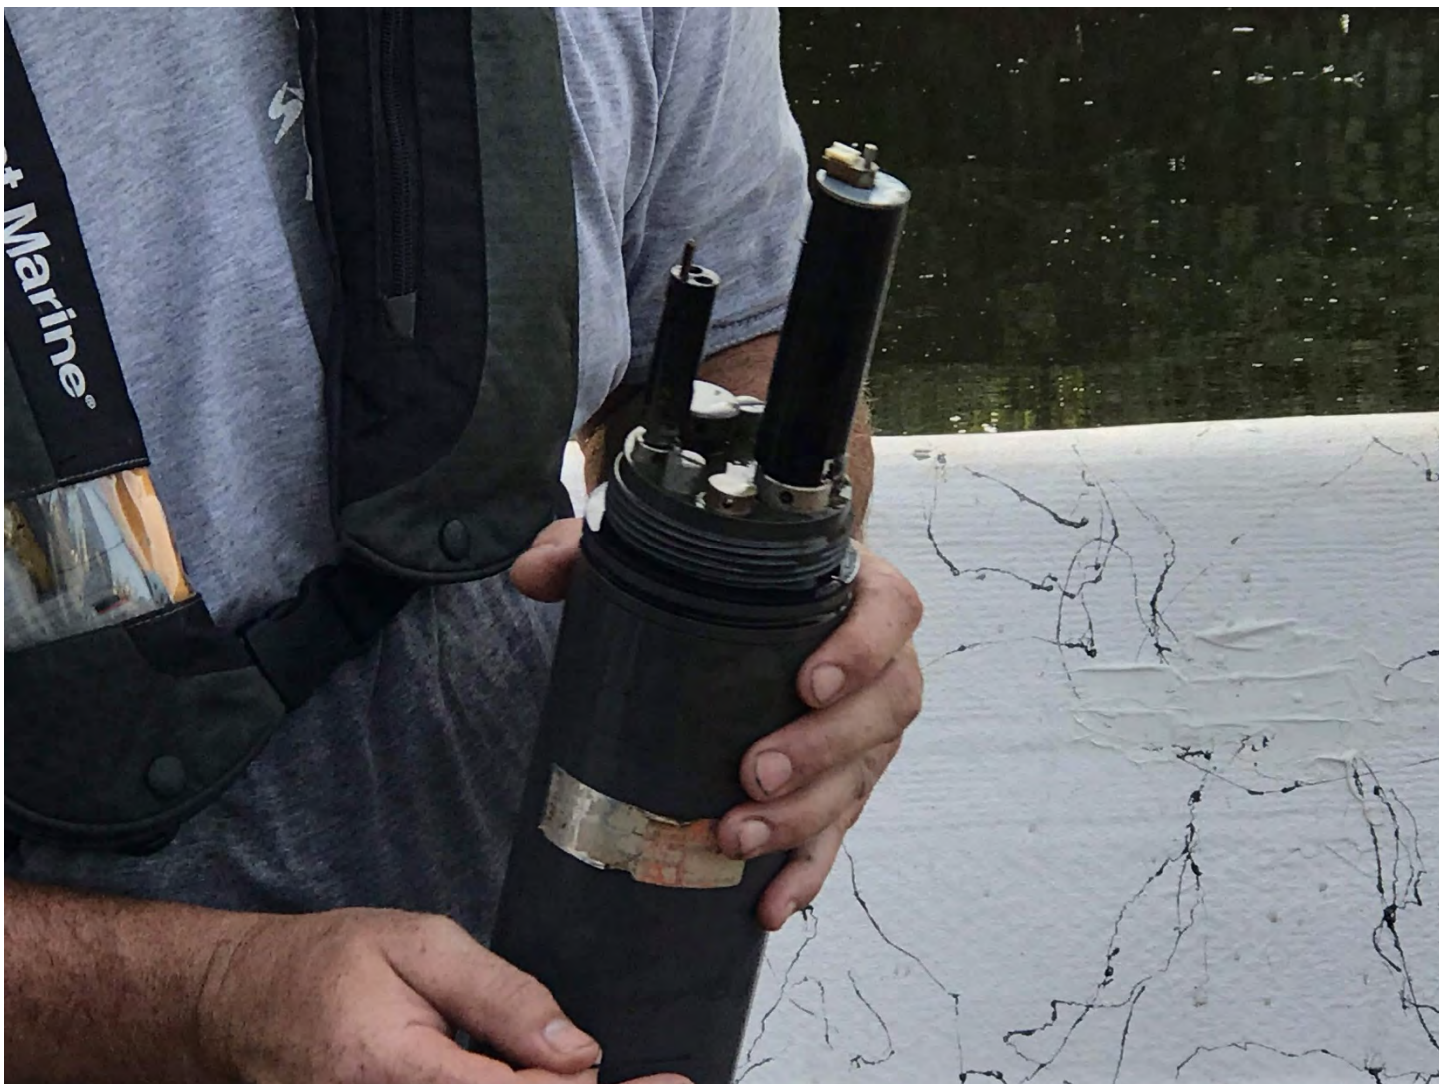
Photograph 15: RM 8.4 bottom YSI sonde wiper replaced.

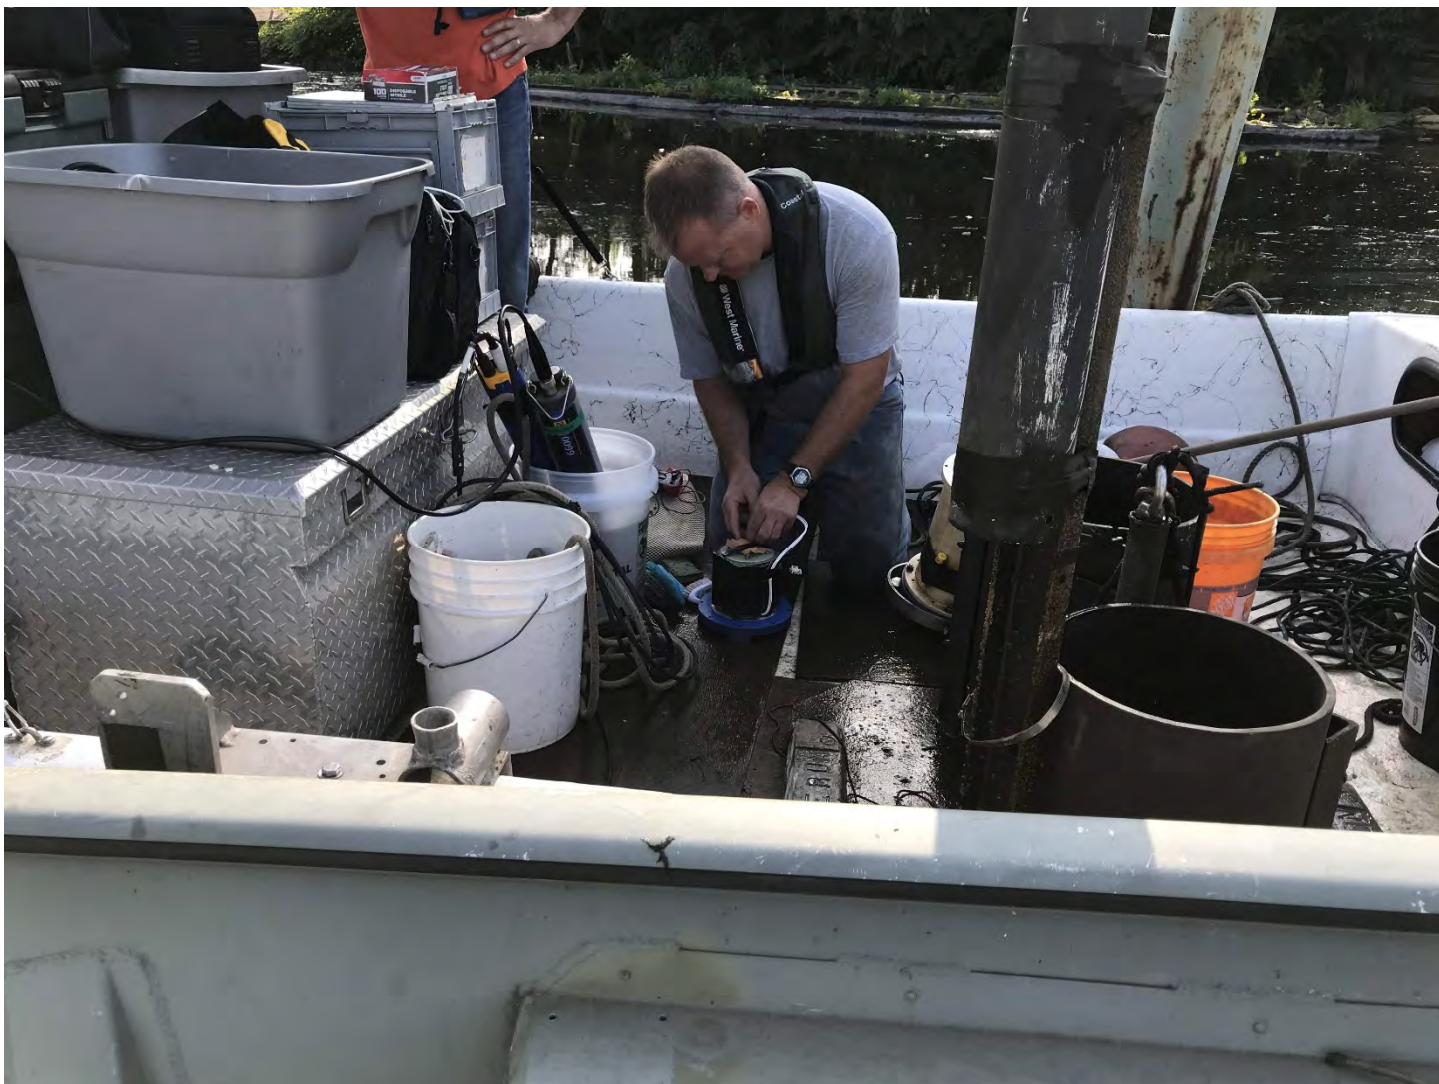
Photograph 16: Replacing RM 8.4 ADCP battery.

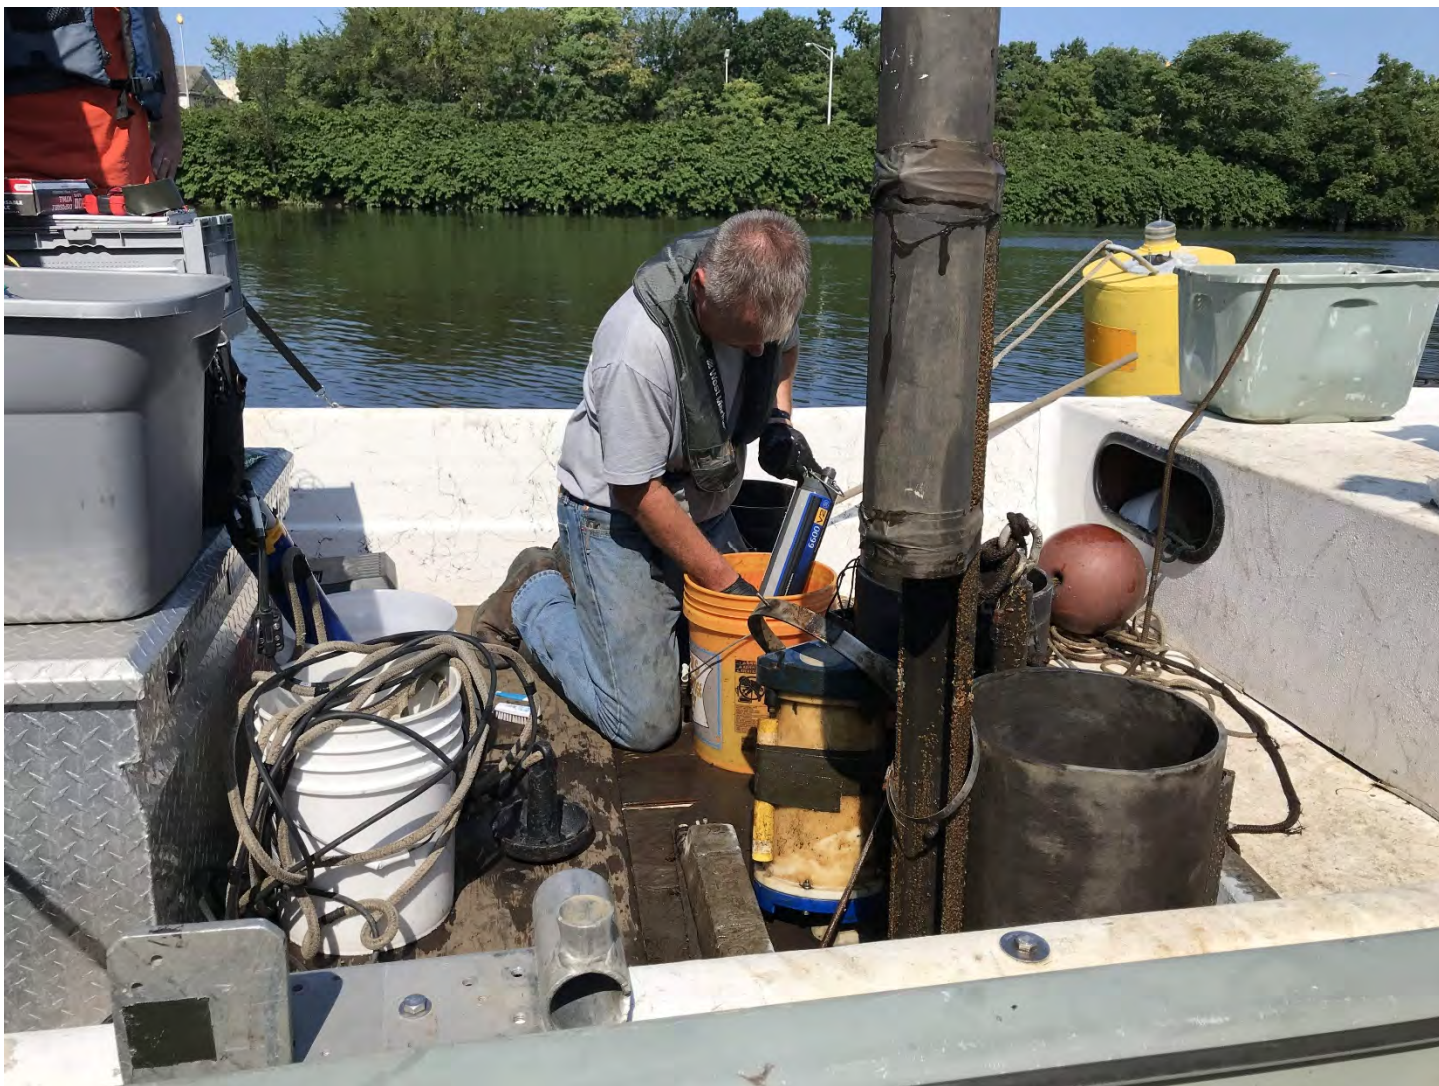
Photograph 17: Cleaning RM 8.4 bottom YSI sonde.
